Flood Control Project Maintenance
2012 Structure Summary Report
Overall Unit and Item Ratings

Madera County FCWCA

Ash And Berenda Slough Control Structures

Flood Control Project Maintenance**2012 Structure Summary Report****Overall Unit and Item Ratings****Madera County FCWCA (cont.)****Fresno River Diversion Weir**

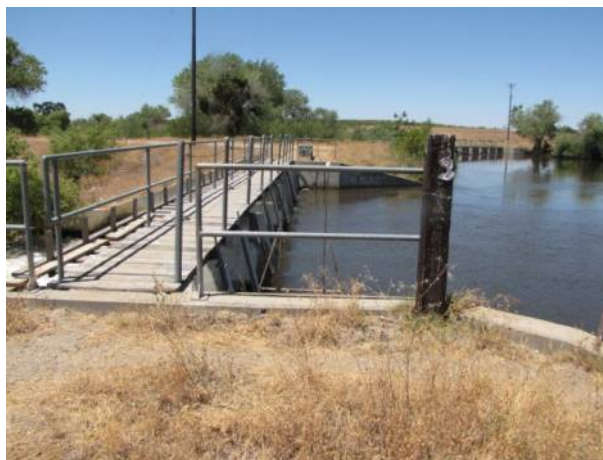
Levee Mile Report Line	1
Start Levee Mile	0.00
End Levee Mile	0.00
Location	
Category	Structures
Item	Photo Documentation
Berenda Slough Control Structure upstream left bank. Photo taken 7-24-2012.	
phillips_t_20120807_024.jpg

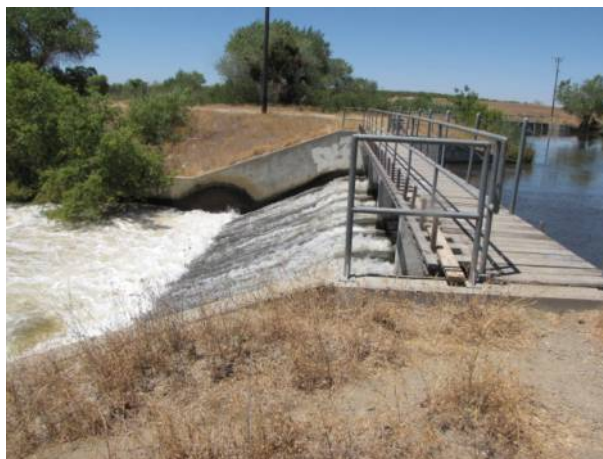
Levee Mile Report Line	1
Start Levee Mile	0.00
End Levee Mile	0.00
Location	
Category	Structures
Item	Photo Documentation
Berenda Slough Diversion Structure downstream left bank. Photo taken 7-24-2012.	
phillips_t_20120807_025.jpg

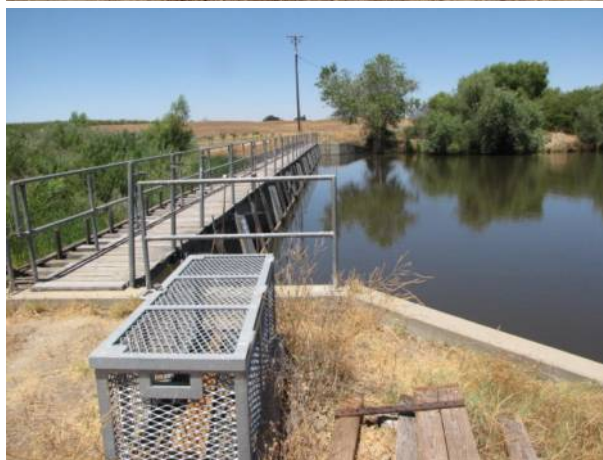
Levee Mile Report Line	1
Start Levee Mile	0.00
End Levee Mile	0.00
Location	
Category	Structures
Item	Photo Documentation
Ash Slough Diversion Structure upstream left bank. Photo taken 7-24-2012.	
phillips_t_20120807_026.jpg

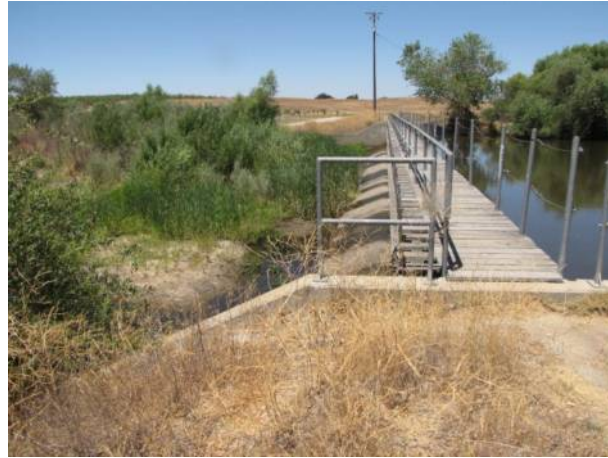
Levee Mile Report Line	1
Start Levee Mile	0.00
End Levee Mile	0.00
Location	
Category	Structures
Item	Photo Documentation
Ash Slough Diversion Structure downstream left bank. Photo taken 7-24-2012.	
phillips_t_20120807_027.jpg

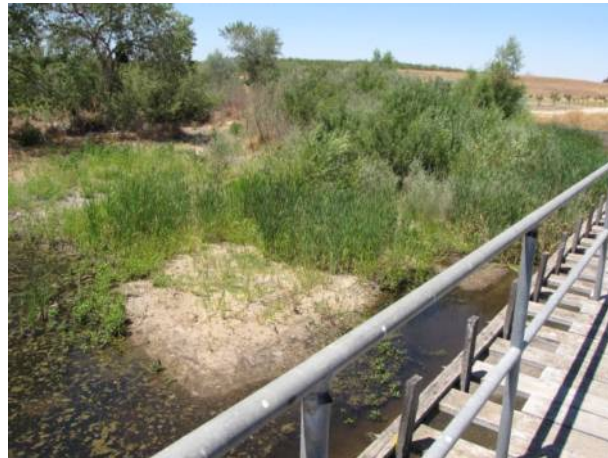
Levee Mile Report Line	2
Start Levee Mile	0.00
End Levee Mile	0.00
Location	
Category	Structures
Item	Vegetation & Obstructions
Ash Slough downstream from Structure. Photo taken 7-24-2012.	
phillips_t_20120807_030.jpg

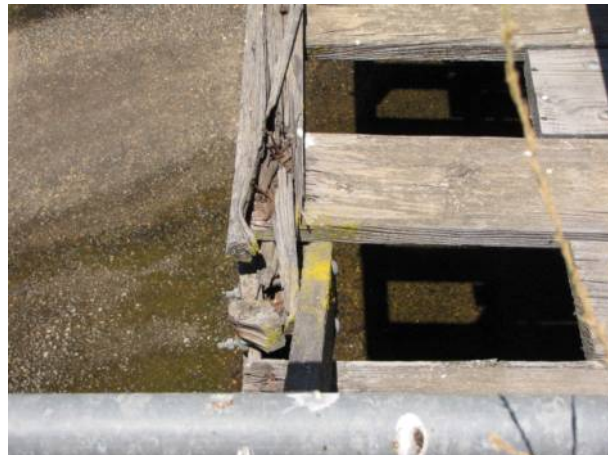
LMR No.	Levee Mile		Category	Item	Location *	Rating **	Action/Comment	GPS Latitude/Longitude		Issue No.
	Start	End						Start	End	Photo
23	0.00	0.00	Structures	Safety		M	Inspector Comments: Minor safety hazards are present, but do not pose an immediate threat to the structure or personnel at the structure. Corrections should be made prior to the next annual inspection. 37.143520 - 120.162171	37.157904 ° -120.124165 °	37.143520 ° -120.162171 °	23 Y

Levee Mile Report Line	23
Start Levee Mile	0.00
End Levee Mile	0.00
Location	
Category	Structures
Item	Safety
Ash Slough Structure damaged timbers not replaced since last inspection. Photo taken 7-24-2012.	
phillips_t_20120807_028.jpg

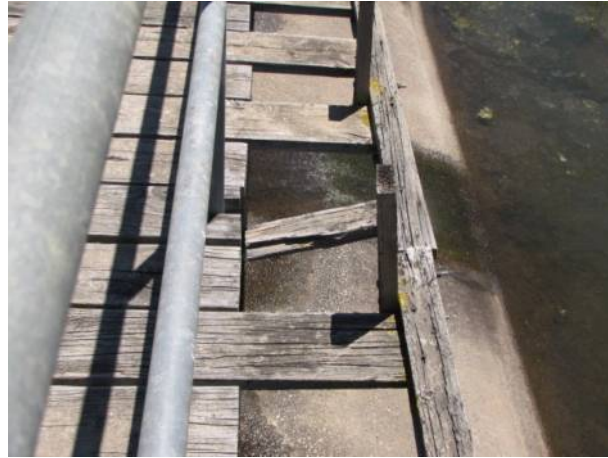
Levee Mile Report Line	23
Start Levee Mile	0.00
End Levee Mile	0.00
Location	
Category	Structures
Item	Safety
Bustes board on catwalk need to be replaced. Photo taken 7-24-2012.	
phillips_t_20120807_029.jpg

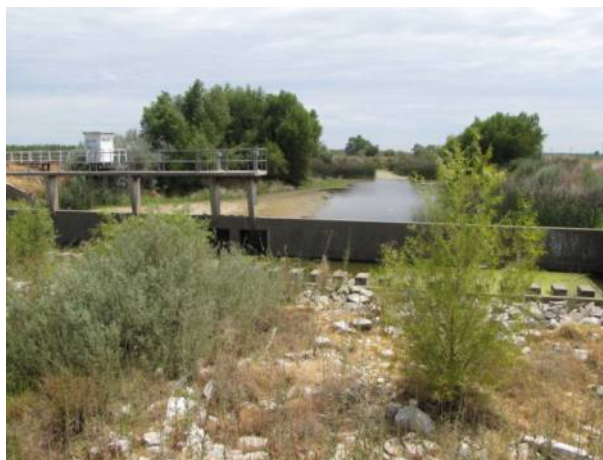
phillips_t_20120723_022.jpg

Fresno River Diversion Weir viewed from bridge crossing. Photo taken 7-19-2012.

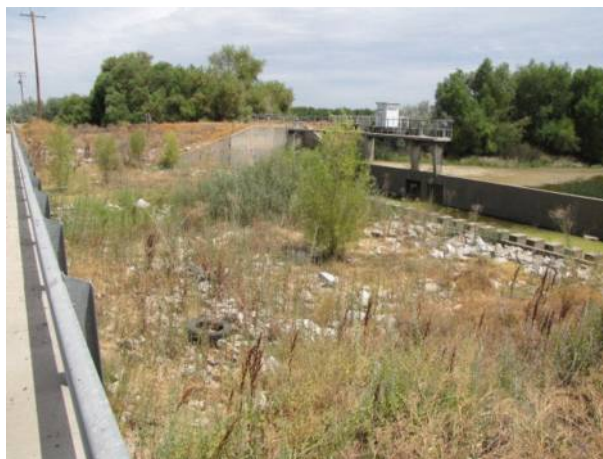
phillips_t_20120723_023.jpg

LMR No.	Levee Mile		Category	Item	Location *	Rating **	Action/Comment	GPS Latitude/Longitude		Issue No.
	Start	End						Start	End	Photo
1	0.00	0.00	Structures	Photo Documentation		N		36.967930 ° -120.255680 °	36.967930 ° -120.255680 °	1 Y
2	0.00	0.00	Structures	Vegetation & Obstructions		M	Inspector Comments: There is a build up of vegetation on the downstream side of the deflectors within the channel of the Fresno River and on the left bank (unit 6) there is buildup of veg. growth inside the security fence area on the bank.	36.967930 ° -120.255680 °	36.967930 ° -120.255680 °	2 Y
3	0.00	0.00	Structures	Shoaling / Sedimentation		A	Inspector Comments: No shoaling or sedimentation present.	36.967930 ° -120.255680 °	36.967930 ° -120.255680 °	3
4	0.00	0.00	Structures	Erosion / Bank Caving		A	Inspector Comments: There was no presence of erosion at this structure during my inspection 7-12-2011	36.967930 ° -120.255680 °	36.967930 ° -120.255680 °	4

Photo shows vegetation downstream of spillway. Photo taken 7-19-2012.
